**ENGINE—3.0L 2V (VULCAN) REVISED OIL PAN
GASKET REPLACEMENT PROCEDURE—NEW
SERVICE KIT—SERVICE TIP**

**Article No.
03-5-3**

FORD: 1986-2001 TAURUS
1990-1991 PROBE
1992-1994 TEMPO
1986-1997 AEROSTAR
1991-2001 RANGER
1995-2000 WINDSTAR

MERCURY: 1986-2001 SABLE
1992-1994 TOPAZ

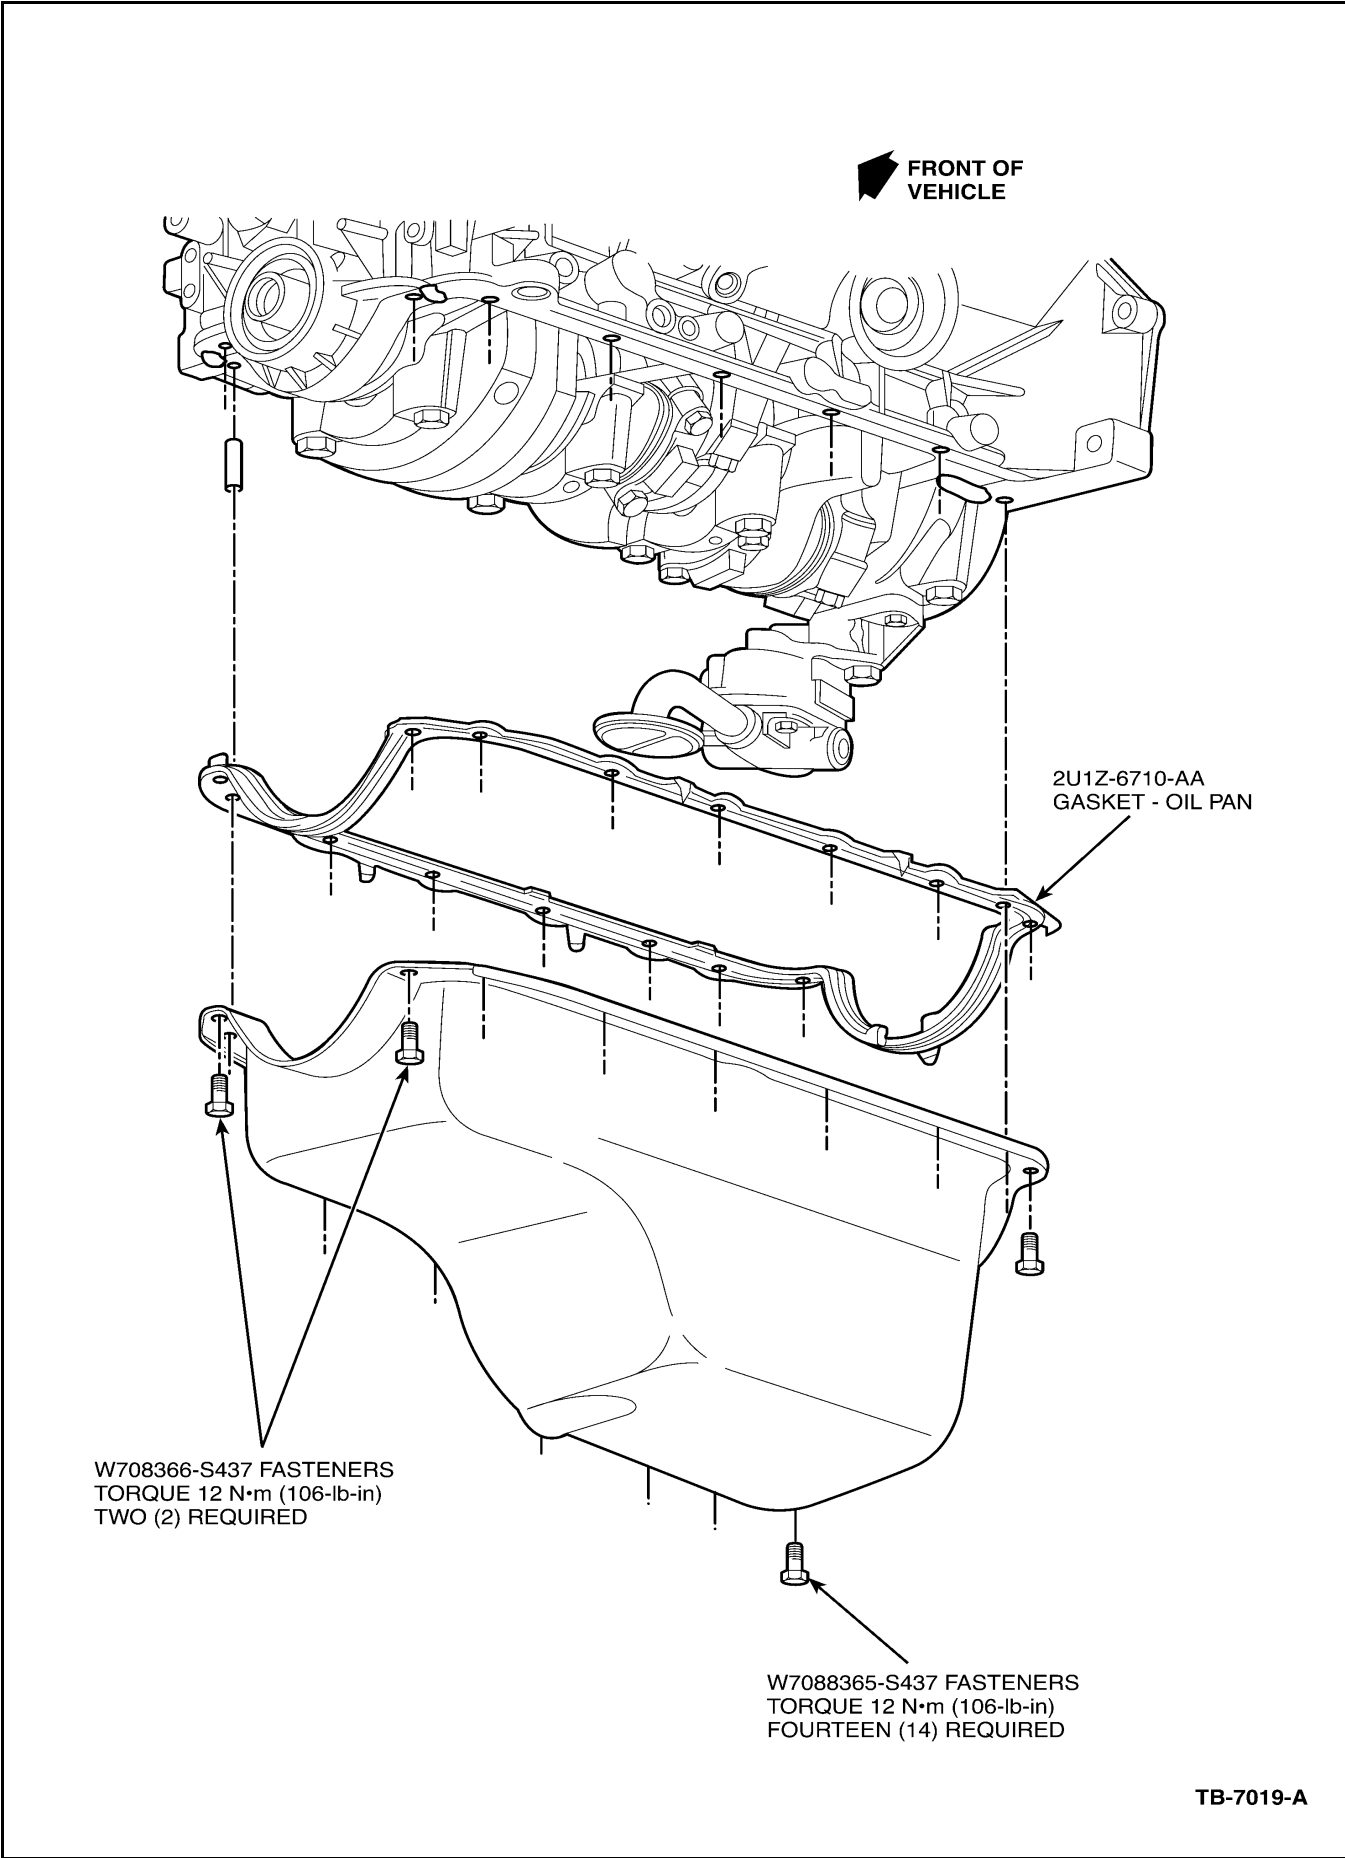
Figure 1 - Article 03-5-3

THE TWO CORNER BOLTS NEAR THE FRONT OF THE ENGINE ARE A DIFFERENT LENGTH.

4. Install the gasket on the oil pan, being careful not to damage the plastic tabs.
5. Install the oil pan to the engine block with the new fastener (bolts) packaged in the service kit, run down all the bolts by hand (Figure 1).

6. Tighten the four (4) corner bolts first to 106 Lb-in (12 N•m).
7. Tighten the remaining fourteen (14) bolts from back to front (alternating from side to side) to 106 Lb-in (12 N•m). Figure 1.
